Buried Photodiode with Floating P+ Surface of Serious Image Lag Problem

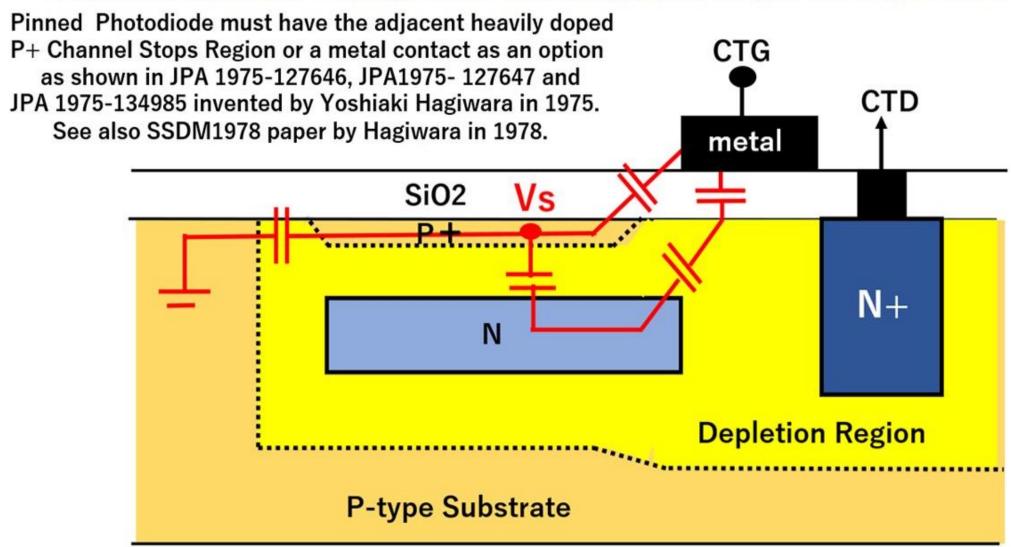
The parasitic capacitance coupling with the surrounding depletion region and the gate oxide.
